THE EROSION BEHAVIOR OF STEEL AS A FUNCTION OF  
MICROSTRUCTURE ON SOLID PARTICLE EROSION

Alan V. Levy

April 1980

LBL-10798c.2

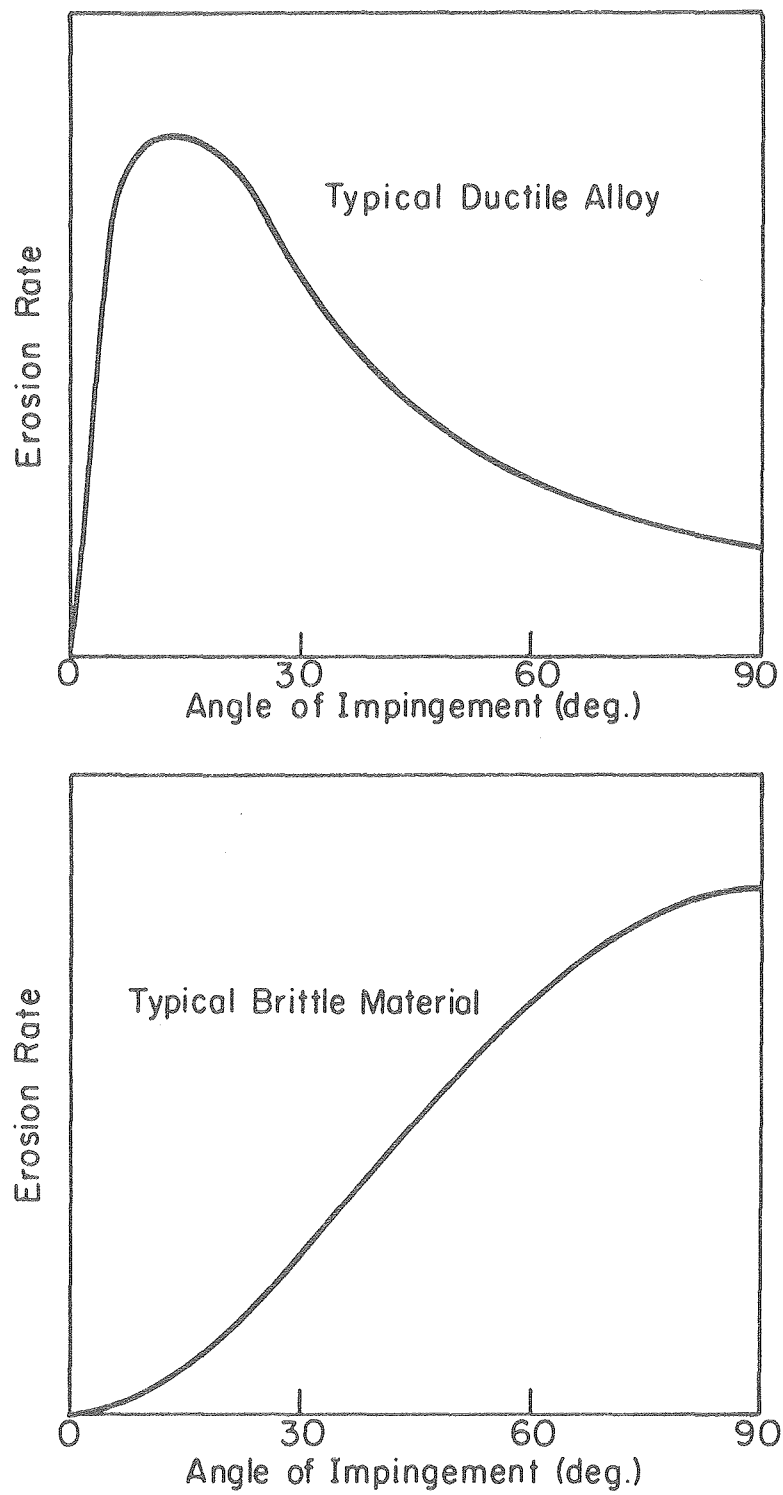
Figure 1

- Figure 1. Plots of erosion rate (grams removed/grams of impacting particles) versus angle of impingement, (degrees) of a) a typical ductile alloy, and b) typical brittle material.

Previous workers in the field have made valuable advances in the understanding of erosion.<sup>6-15</sup> It has been determined that erosion of ductile alloys strongly depends on particle velocity and angle of impingement,  $\alpha$ , as shown in Fig. 1, and, to a lesser degree on particle size, shape, density and solids loading in the fluid stream. The impingement angle for maximum erosion is usually found to be from 15° to 30° for ductile alloys. Brittle materials behave quite differently than ductile materials (see Fig. 1).

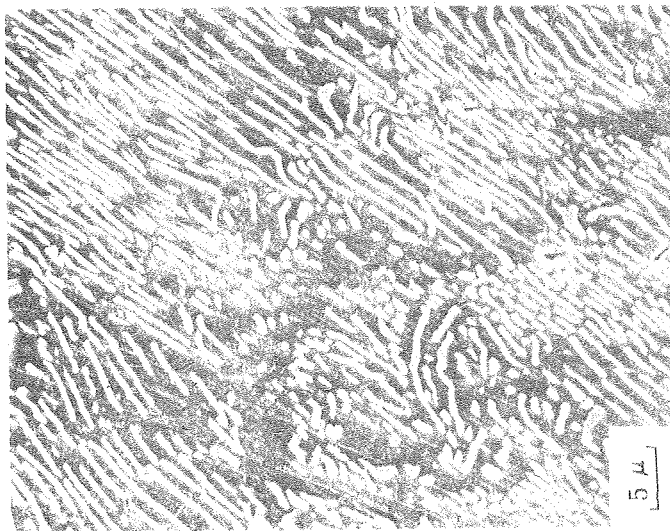
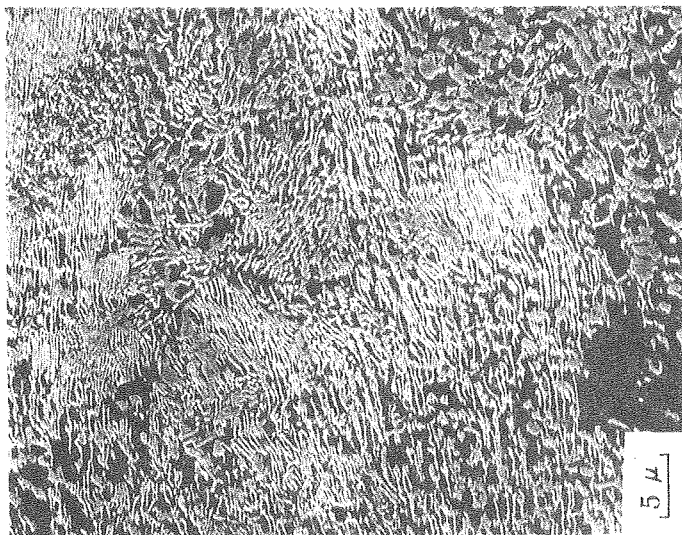
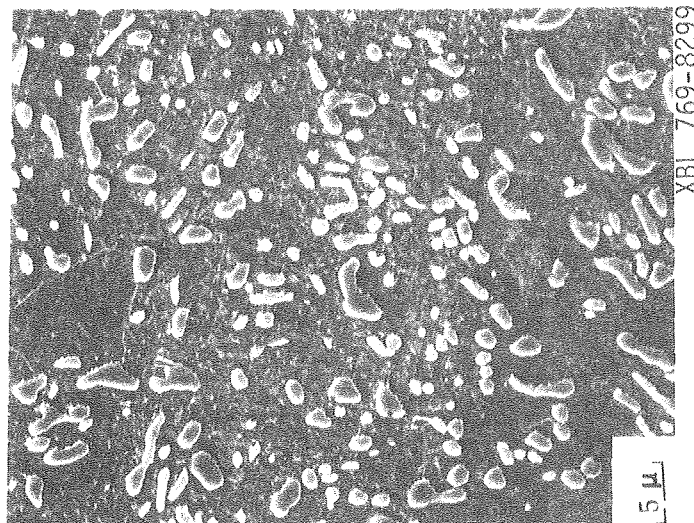
Figure 2

- Figure 2. Scanning electron micrographs of 1075 steel in the coarse pearlite, fine pearlite, and spheroidized microstructures.
- Figure 3. Photograph of room temperature erosion tester.

COARSE PEARLITE

Hardness -  $R_B$  90  
Lamellar Spacing  $\sim 1 \mu m$

FINE PEARLITE

Hardness -  $R_B$  99 ( $R_C$  20)  
Lamellar Spacing  $\sim 0.25 \mu m$

SPHEROIDIZED

Hardness -  $R_B$  79  
Sphere Diameter  $\sim 1.25 \mu m$

The commercial plain carbon 1075 and 1020 steels were obtained for erosion testing and cut into samples 0.75 in x 2.5 in x 0.125 in. The 1075 steel was heat treated to fine pearlite, coarse pearlite, and spheroidized microstructures (Fig. 2) in a high vacuum controlled atmosphere furnace to prevent chemical changes on the sample surface. Coarse pearlite was formed by austenitizing at  $875^{\circ} \pm 3^{\circ}\text{C}$  for 30 minutes, furnace cooling to  $700^{\circ} \pm 3^{\circ}\text{C}$  in a stream of argon gas, holding for 3 hours, and furnace cooling to room temperature. Fine pearlite was formed by austenitizing at  $875^{\circ} \pm 3^{\circ}\text{C}$  for 30 minutes, fast cooling to  $600^{\circ} \pm 3^{\circ}\text{C}$  in a stream of argon gas, holding for 30 minutes, and cooling to room temperature. The spheroidized specimens were heat treated by encapsulating the samples in quartz tubes filled with argon, austenitizing at  $875^{\circ} \pm 5^{\circ}\text{C}$  for 30 minutes, furnace cooling to  $700^{\circ}\text{C}$ , holding for 10 days, and air cooling to room temperature.

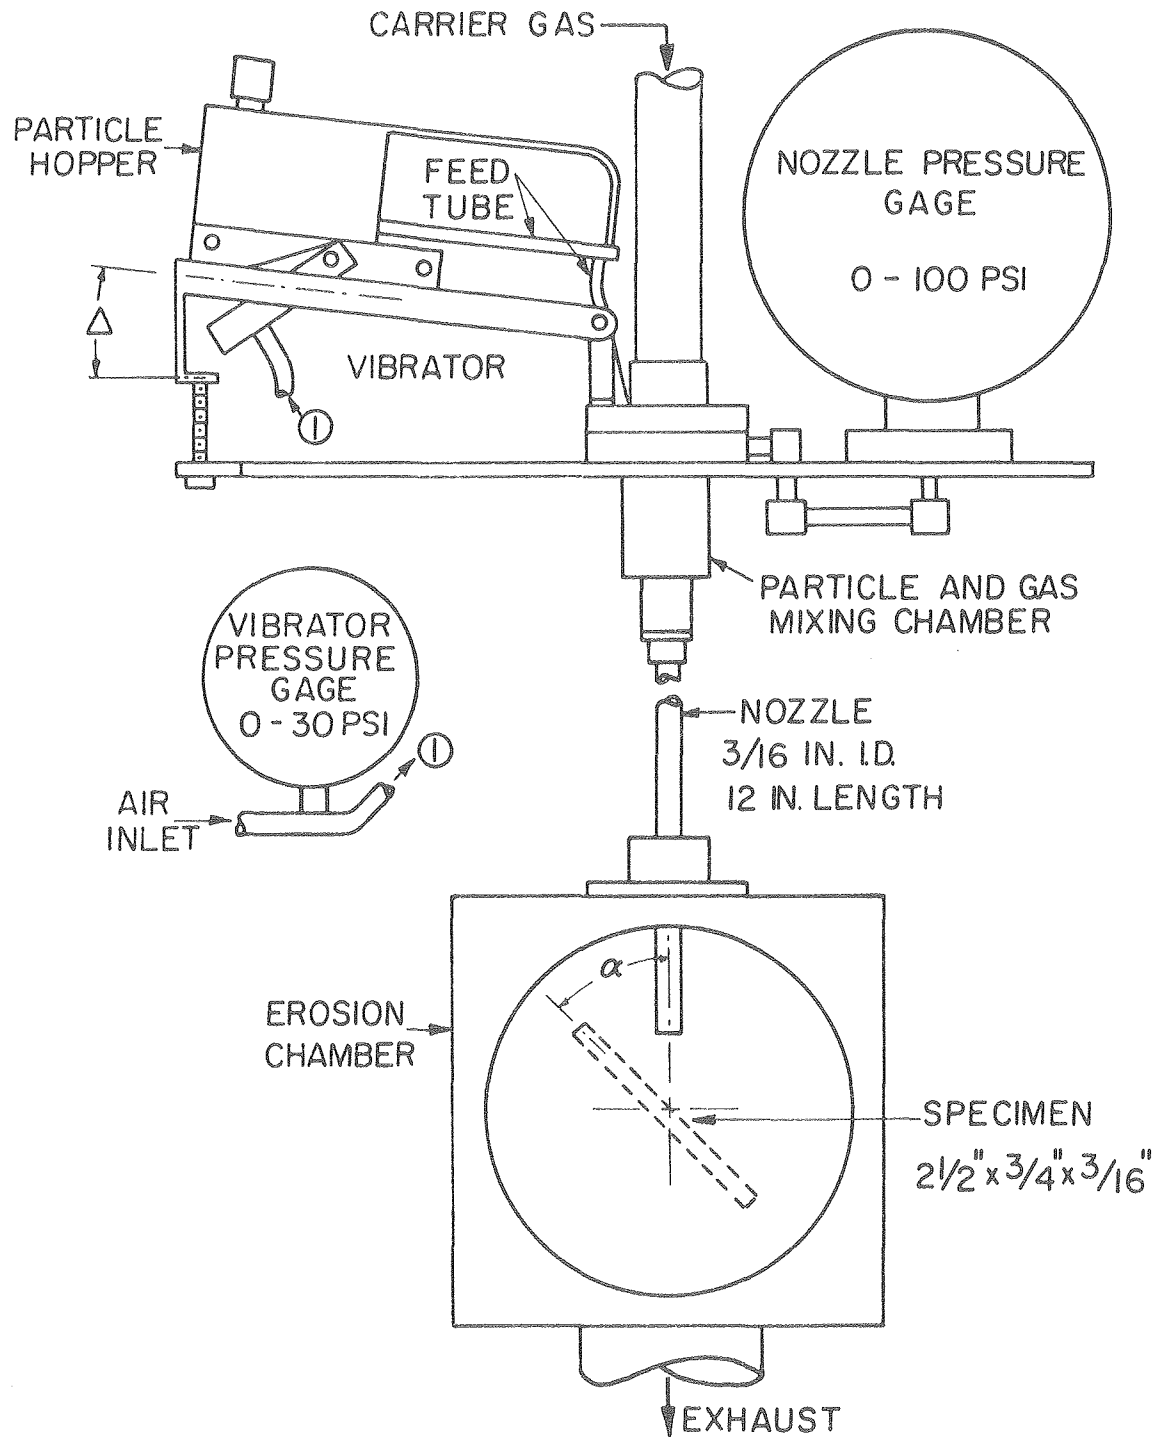
Figure 4

- Figure 4. Schematic diagram of room temperature erosion tester.
- Figure 5. A. Schematic diagram of erosion tester with rotary particle velocity testing device attached.

The erosion testing was conducted at room temperature using an air blast tester shown in Figs. 3 and 4. The tester operated by feeding the eroding particles from a vibrating hopper into a stream of gas. The particle feed rate was found to be accurate and constant at 20 grams/minute, a solid loading of 0.6 gm SiC/gm air at 30.5 mps (100 fps) and 0.36 gm SiC/gm air at 61 mps (200 fps) for the size and shape of particles used in this study. Angular silicon carbide particles were used as the eroding material having a hardness of about 4500 (VHN) and an actual (true) density of 3.2 grams/cm<sup>3</sup>. Most erosion testing was conducted using +65 -60 mesh (240  $\mu\text{m}$  diameter) particles. The testing device allowed for choice of particle velocity by changing the pressure drop and gas flow rate across a 0.305 m (12") long by 4.77 mm (0.1875") ID stainless steel nozzle. Particle

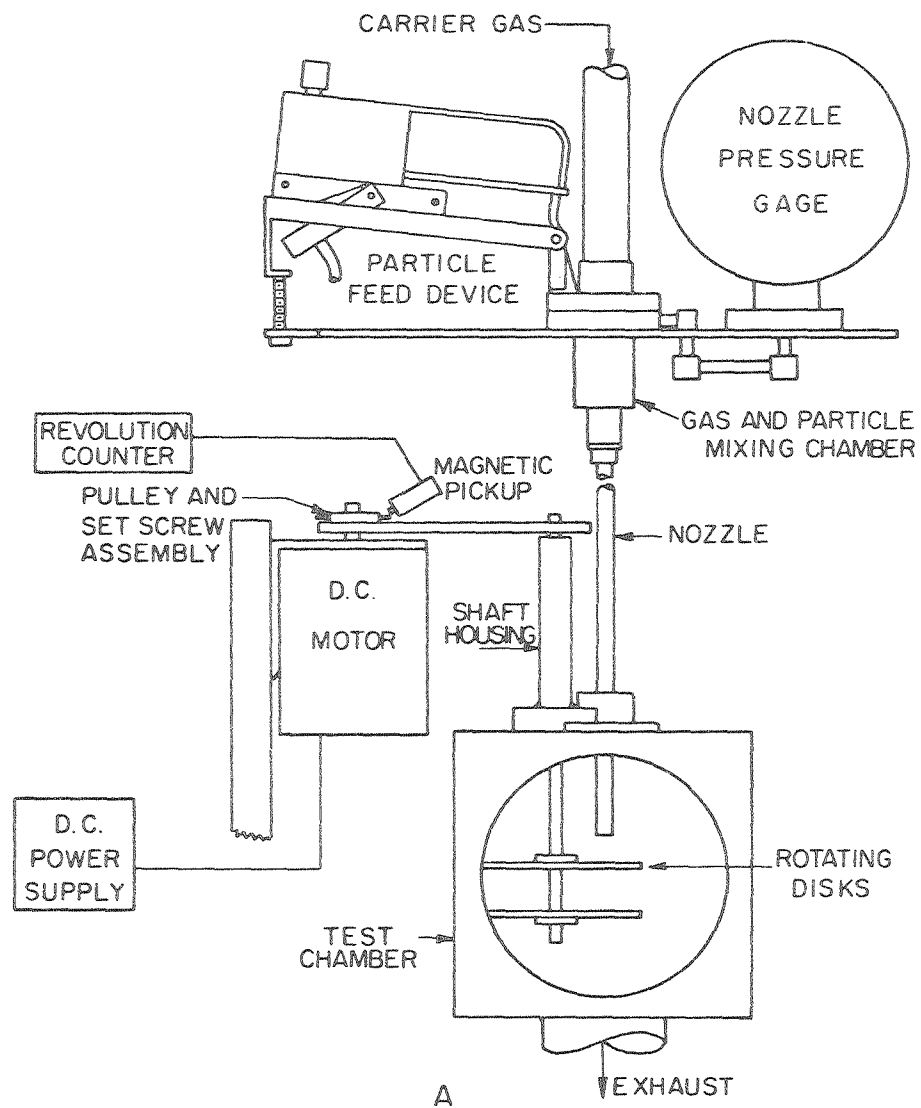
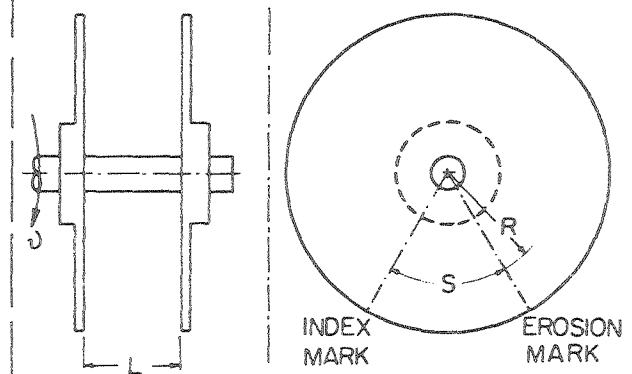
Figure 5

B. Description of variables for particle velocity measurements.
- Figure 6. Plot of engineering stress versus engineering strain for 1075 steel – coarse pearlite and spheroidized.

$L$  = DISK SEPARATION  
 $S$  = ARC LENGTH BETWEEN EROSION MARKS  
 $R$  = RADIUS TO ARC LENGTH  
 $\omega$  = ANGULAR VELOCITY - REV/SEC  
 $V_p$  = PARTICLE VELOCITY  
 $= 2\pi R\omega L/S$

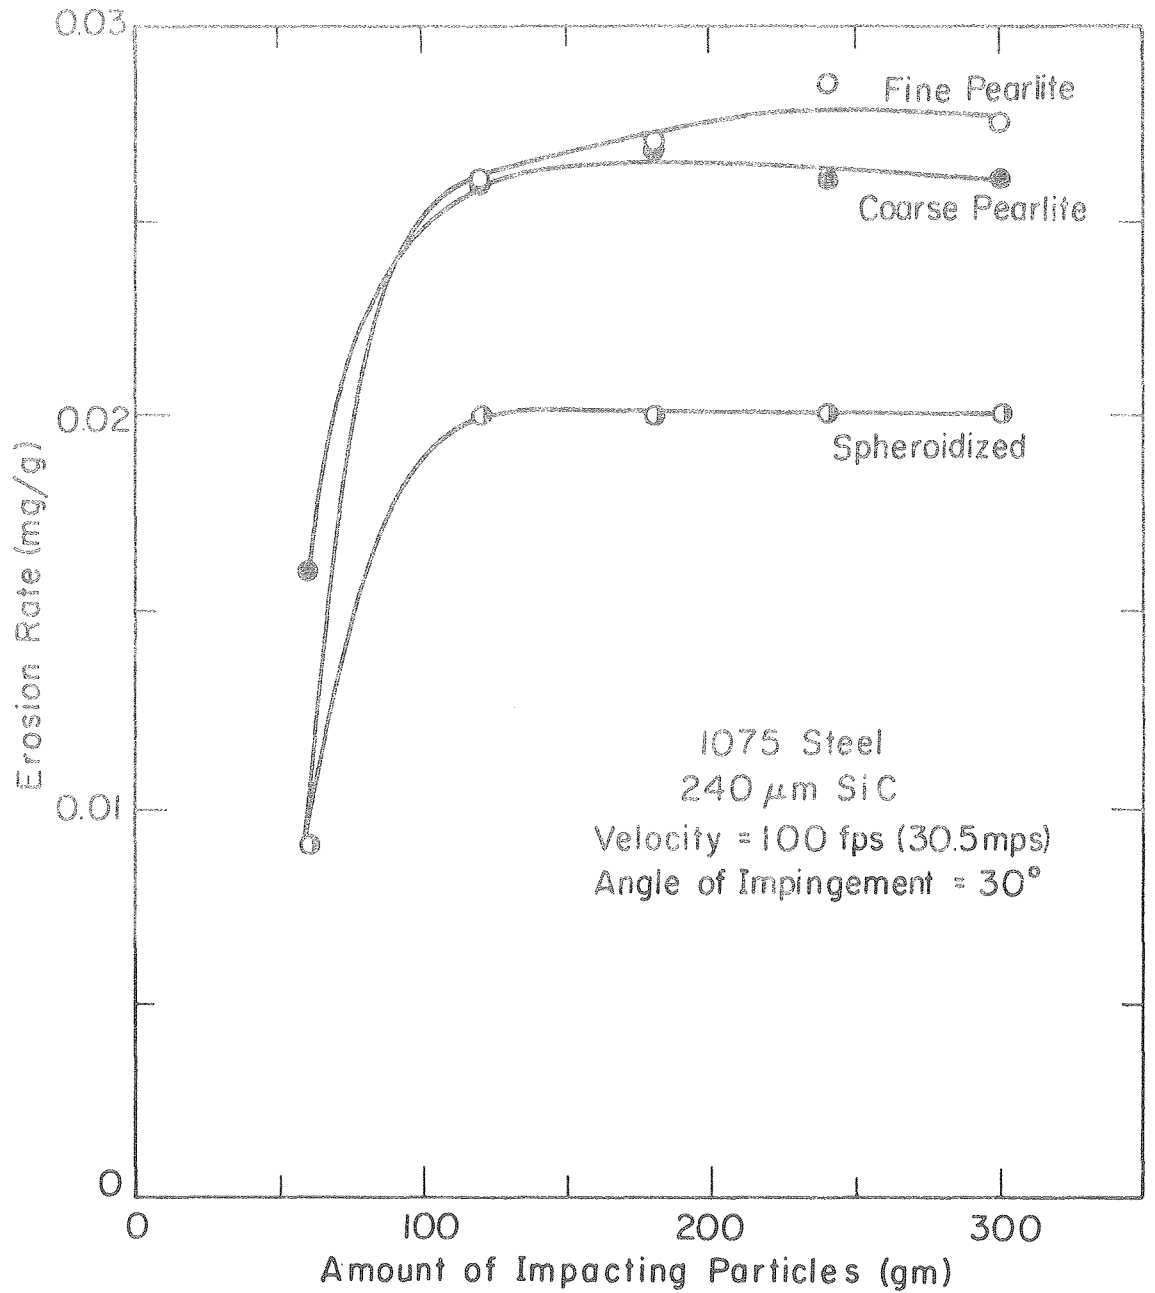
Figure 7

- Figure 7. Plot of erosion rate (mg/g) versus amount of impacting particles (gm) for 1075 steel – coarse pearlite, fine pearlite, and spheroidized – using 240  $\mu\text{m}$  diameter SiC.  
 $V_p = 30.5 \text{ mps (100 fps)}$ ,  $\alpha = 30^\circ$ .

Results of a typical multiple particle erosion test for the three different microstructures of the 1075 steel are shown in Fig. 7. This curve was made for a test particle velocity of 30.5 mps (100 fps) and an angle of impingement of  $30^\circ$ . The curve shows that after steady state erosion had begun (the horizontal portion of the curve) the spheroidized microstructure eroded less than either the coarse or fine pearlite. It should also be noted that there is a definite threshold region of increasing erosion rate before steady state erosion begins.

The threshold behavior before steady state erosion begins, as seen in Figs. 7 and 8 (curves of Erosion Rate vs. Amount of Impacting Particles), is more pronounced at particle velocities of 30.5 mps (100 fps) than at 61 mps (200 fps). Others have observed this type of behavior at normal angles of impact and have attributed it to eroding particle deposition in the sample.<sup>9</sup> At glancing angles the deposition and therefore the threshold would disappear. In the present study, a low initial erosion rate was observed at all angles of impingement at a particle velocity of 30.5 mps (100 fps) and at 90° at a particle velocity of 61 mps (200 fps). Since the threshold was quite pronounced at glancing angles, it was believed that SiC deposition was not the primary cause for the low initial weight loss.

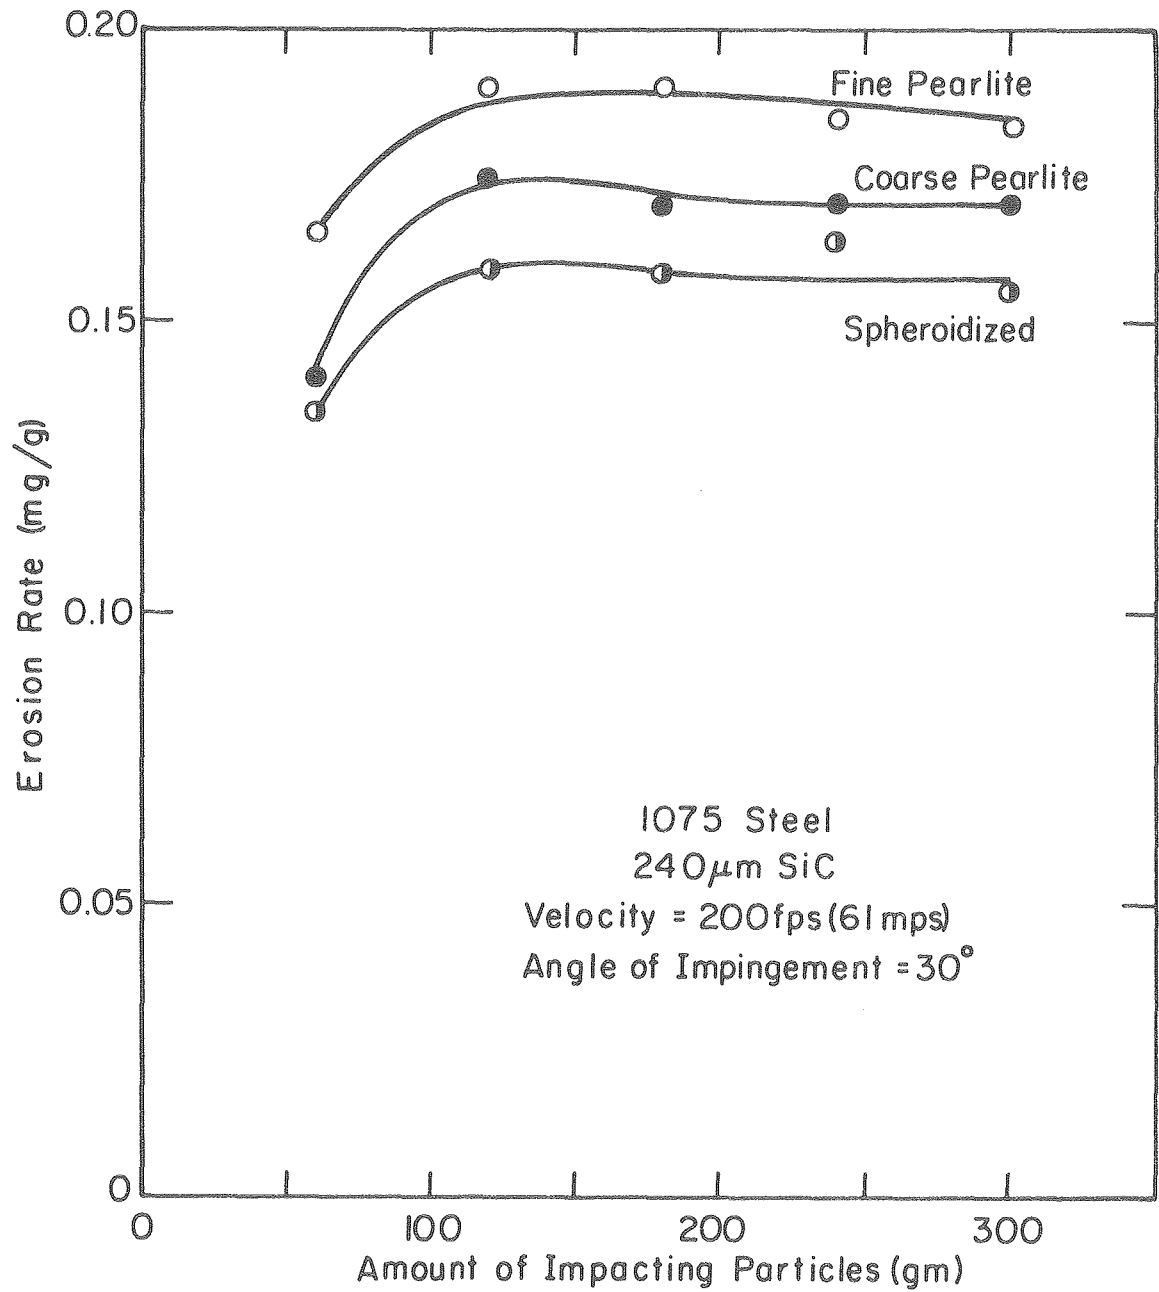
Figure 8

- Figure 8. Plot of erosion rate (mg/g) versus amount of impacting particles (gm) for 1075 steel – coarse pearlite, fine pearlite, and spheroidized – using 240  $\mu\text{m}$  SiC.  
 $V_p = 61 \text{ mps (200 fps)}$ ,  $\alpha = 30^\circ$ .

Erosion data at a particle velocity of 61 mps (200 fps) also show that the spheroidized structure eroded less than the fine or coarse pearlite structures (see Fig. 8). At 61 mps (200 fps), however, the threshold region is not as pronounced as a particle velocity of 30.5 mps (100 fps).

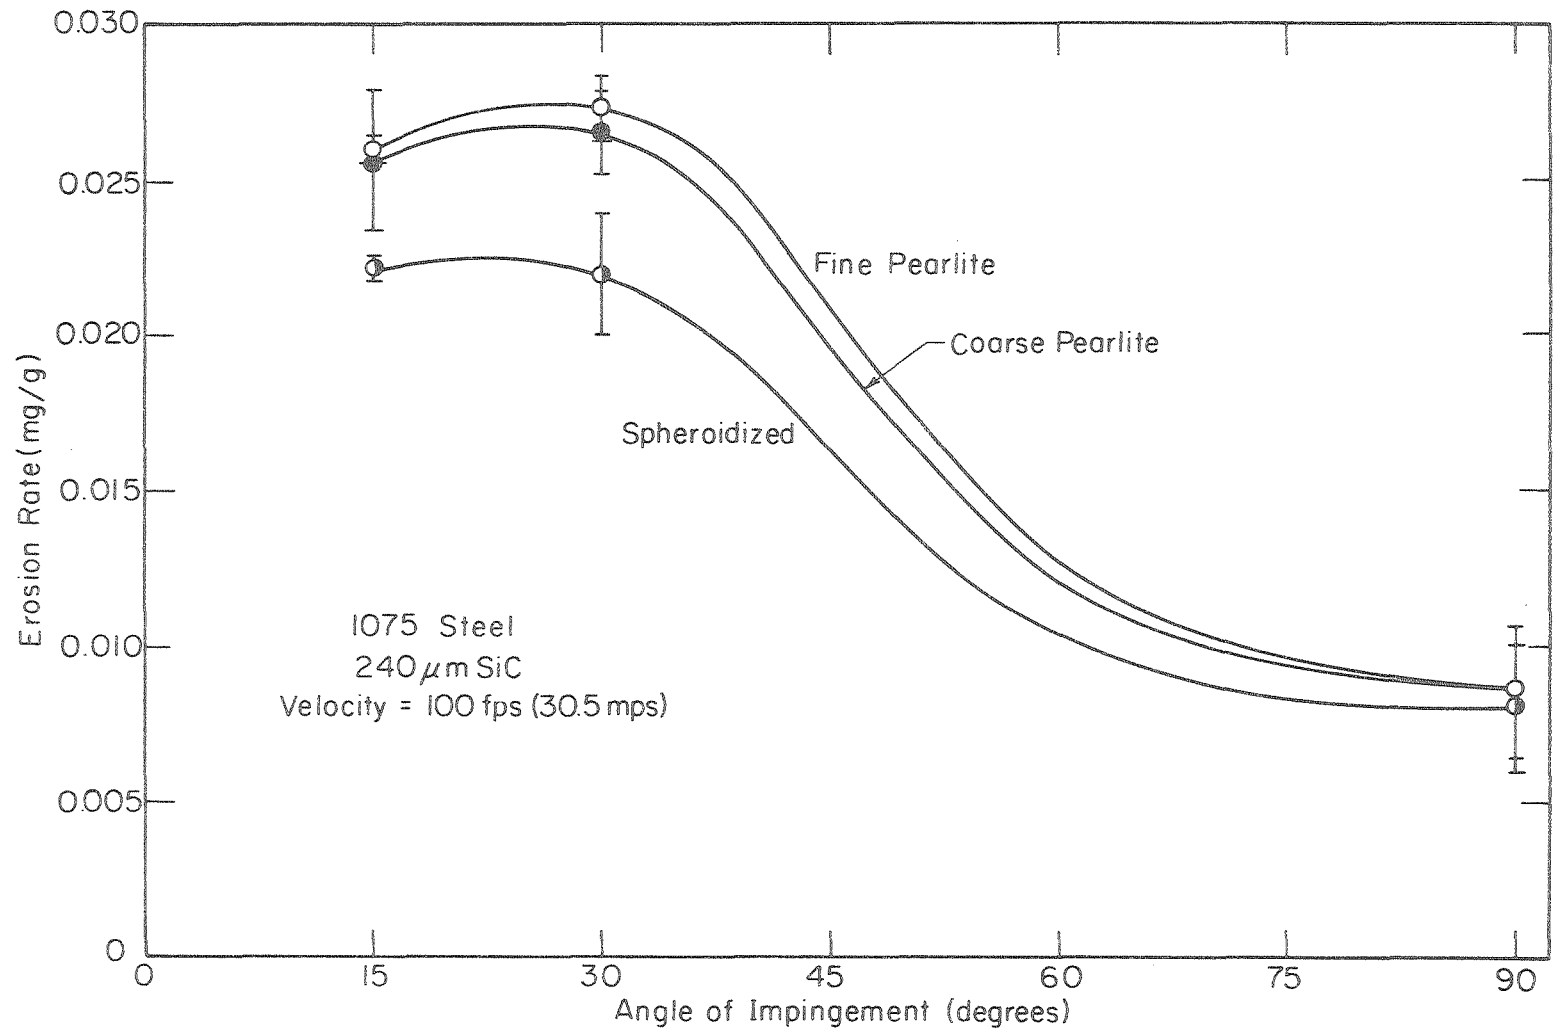
Figure 9

- Figure 9. Plot of erosion rate (mg/g) versus angle of impingement (degrees) for 1075 steel in the coarse pearlite, fine pearlite, and spheroidized microstructures using 240  $\mu\text{m}$  SiC.  $V_p = 30.5$  mps (100 fps).

Erosion rates can be compared for the three microstructures at all angles of impingement on erosion rate vs. angle of impingement curves for 30.5 and 61 mps (see Figs. 9 and 10). The curves are typically shaped for ductile alloys. Data scatter bands for 15° and 30° show that the pearlitic steel curves were essentially the same at 30.5 mps (100 fps) velocity while the spheroidized steel curve was lower. For 61 mps (200 fps) the order of performance was the same but the amount of difference in erosion among the microstructures had changed.

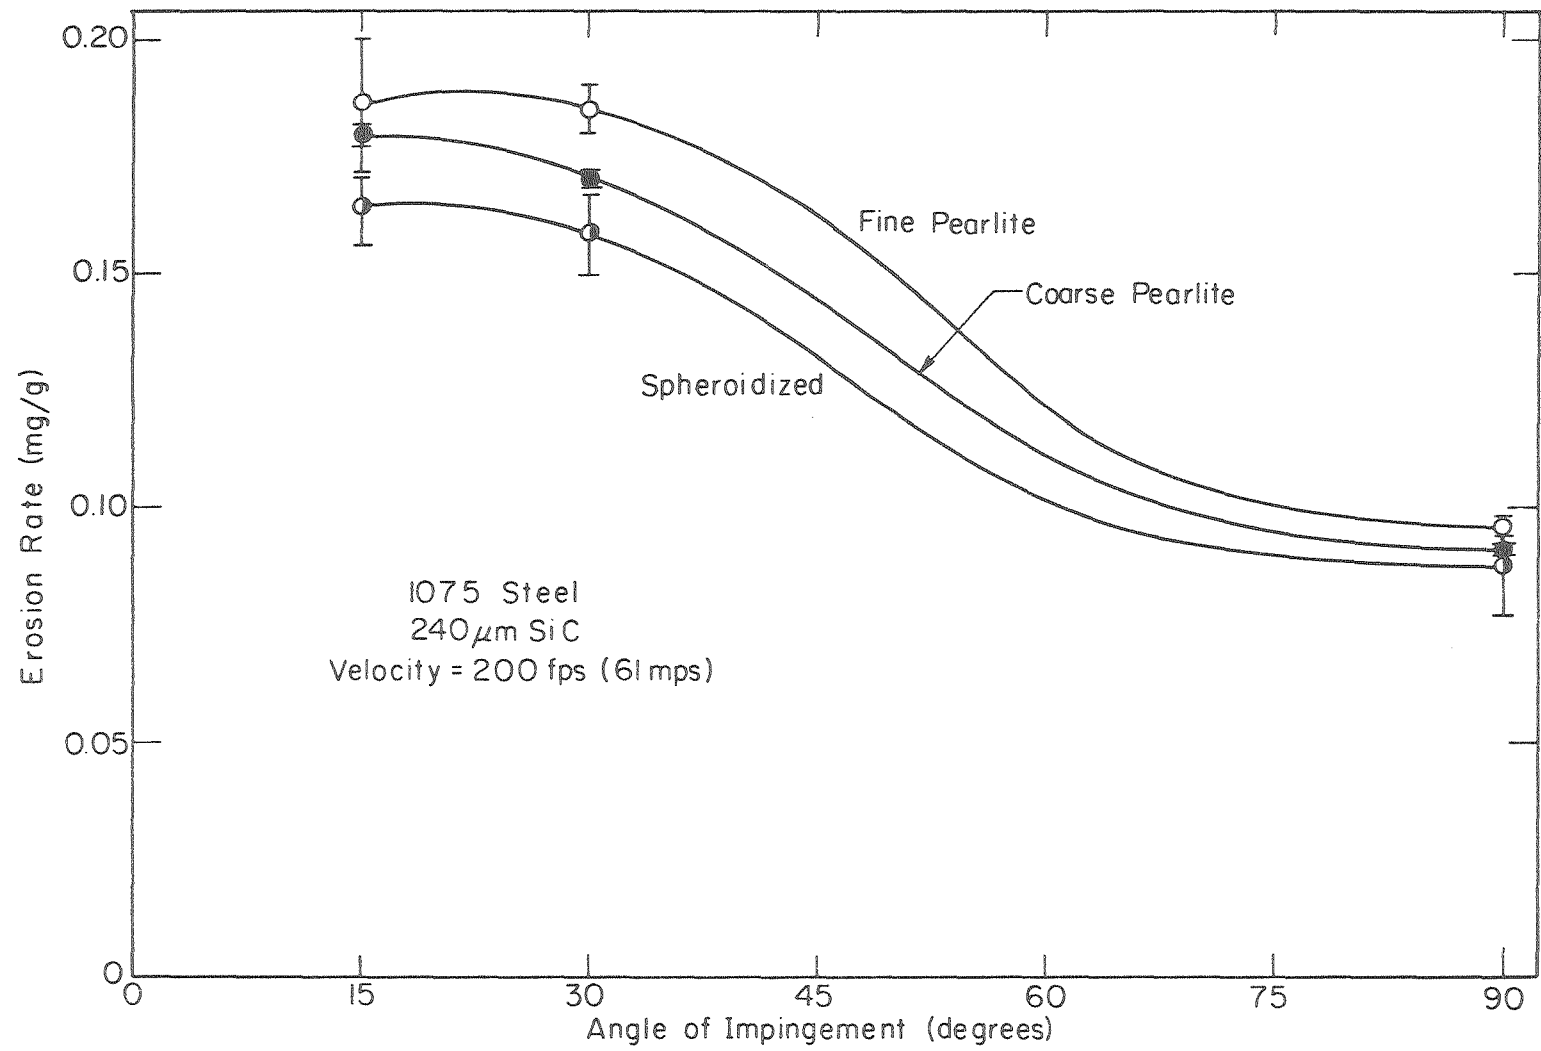
Figure 10

- Figure 10. Plot of erosion rate (mg/g) versus angle of impingement (degrees) for 1075 steel in the coarse pearlite, fine pearlite, and spheroidized microstructures using 240  $\mu\text{m}$  SiC.

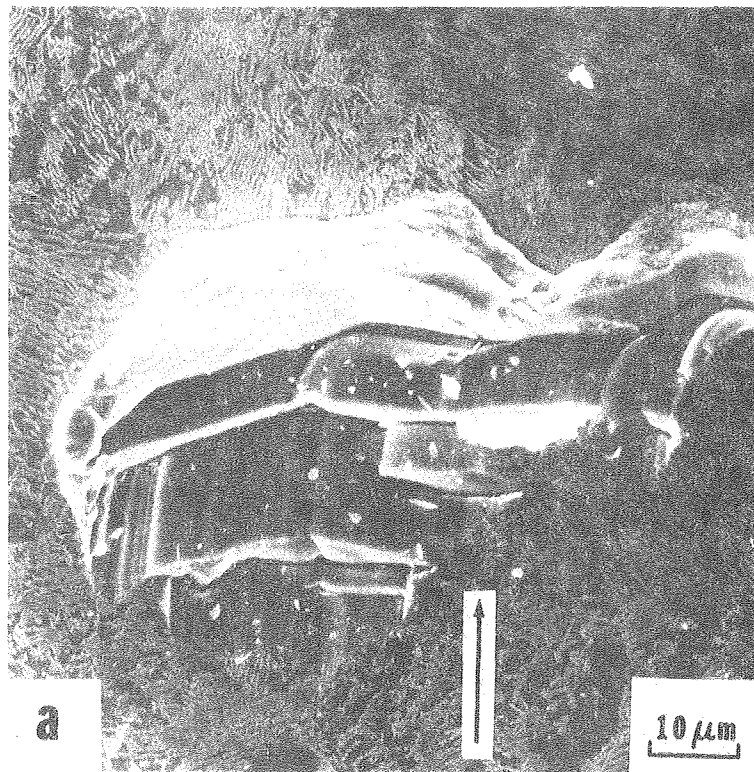
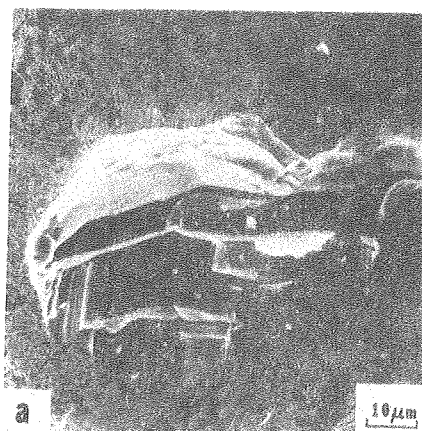
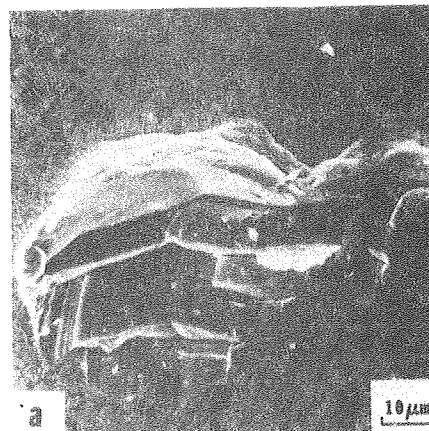
Figure 11

- Figure 11. Photomicrograph of single particle impact crater on 1075 steel (coarse pearlite) using 240  $\mu\text{m}$  SiC.  $V_p = 61$  mps (200 fps),  $\alpha = 15^\circ$ . Stereo pair can be viewed with stereo viewer found in back cover of ASM Handbook, Vol. 9.

surface as seen in Figs. 11 and 12. This type of surface fracture would be expected because of the brittleness of the cementite plates. The ferrite matrix, being very soft and ductile, appears to be torn away leaving the plates exposed. The spheroidized steel under single particle impact showed no severe cracking but rather exhibited a mechanism where the ferrite matrix was plastically deformed with carbide particles lying near or on the surface after impact (see Fig. 13).

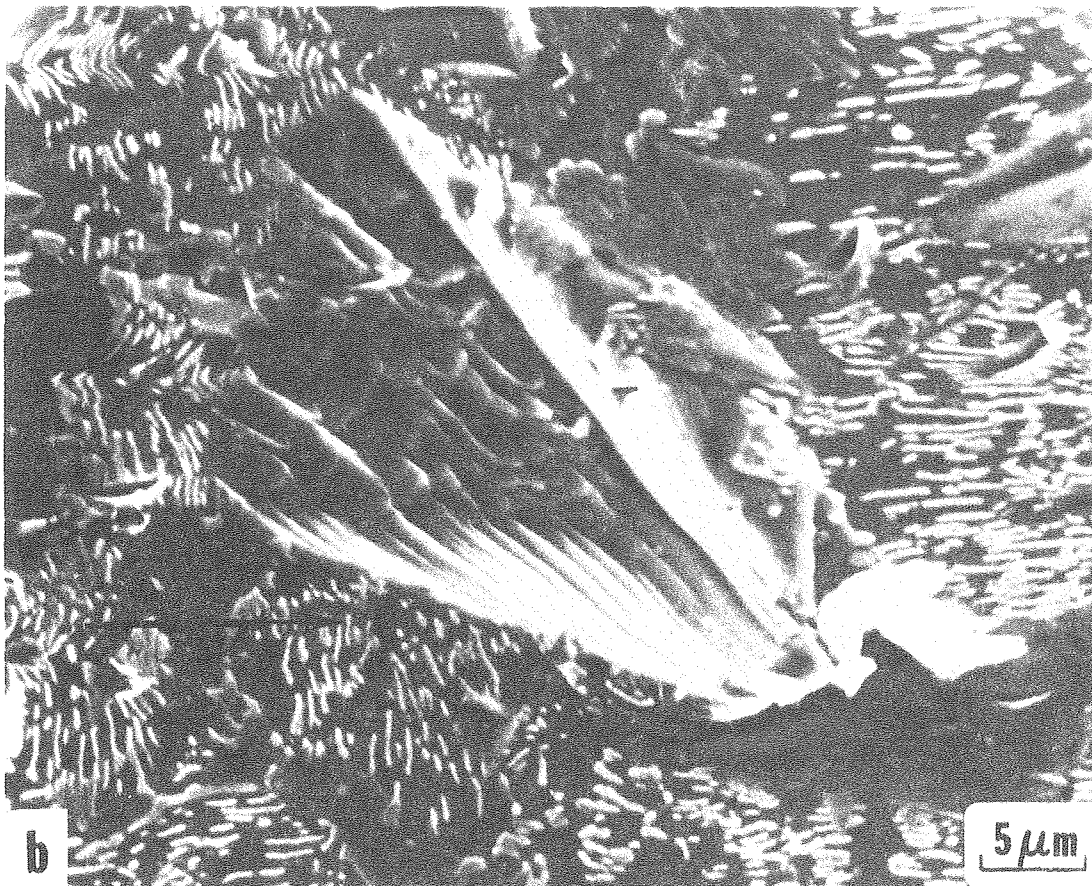
Figure 12

- Figure 12. Photomicrograph of a single particle impact crater on 1075 steel (coarse pearlite) using 240  $\mu\text{m}$  SiC.  $V_p = 107$  mps (350 fps),  $\alpha = 15^\circ$ .

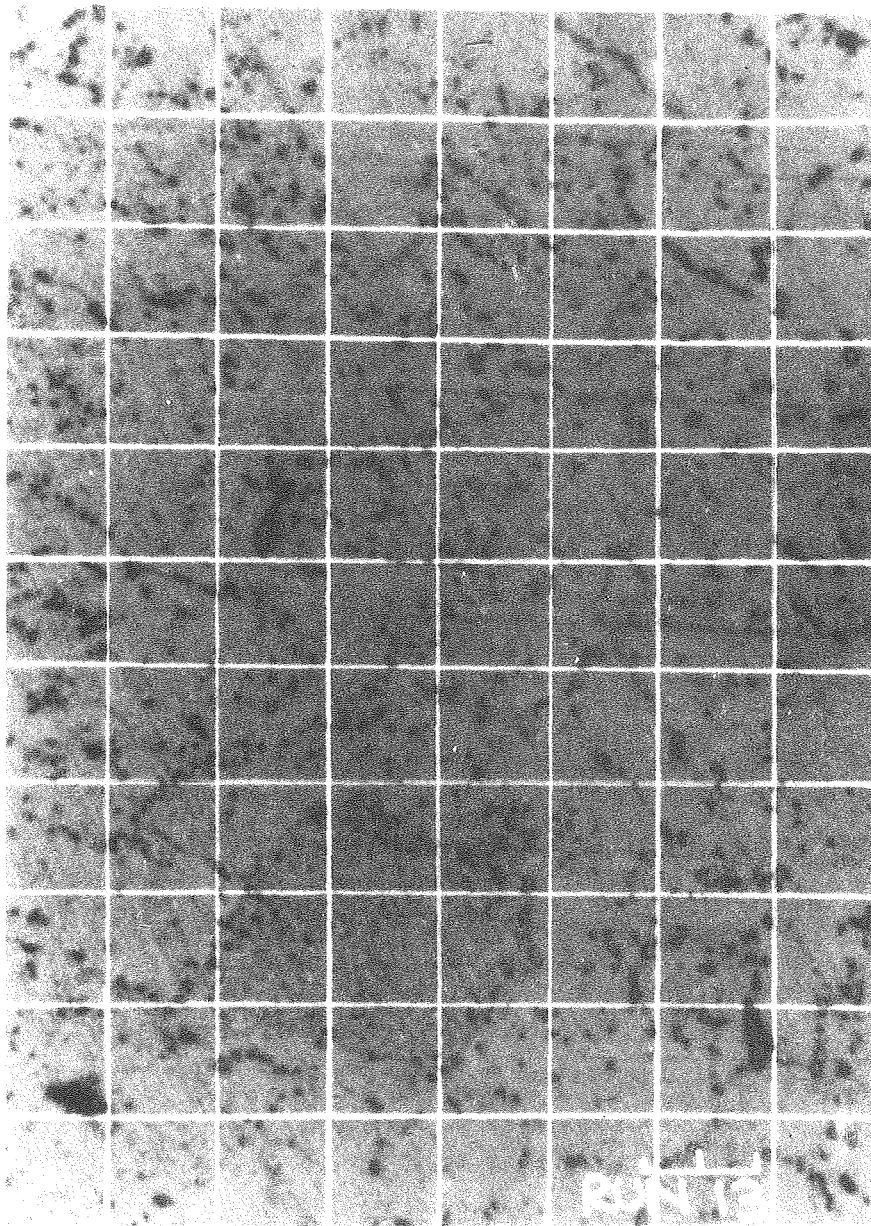
Figure 18

AVERAGE PARTICLE SPACING	3.40 MICRONS
AVERAGE PARTICLE SIZE	.5 MICRONS
MINIMUM PARTICLE SIZE	.1 MICRON
MAXIMUM PARTICLE SIZE	2 MICRONS

The three different spheroidal microstructures tested are shown in Figs. 18-20 along with data on their carbide particle sizes and spacings. Grid maps of each microstructure were made to determine their particle spacings and densities. Run 1 (Fig. 18) had the smallest size particles and the shortest interparticle spacing. Run 2 had roughly half the number of carbide particles, twice the average particle size and twice the average particle spacing of Run 1. Run 3 had very large particles compared to Runs 1 and 2, much greater particle spacings and considerably fewer number of particles. Run 1 used the hardest steel,  $R_B$  30, Run 2's steel was slightly softer,  $R_B$  25 and Run 3's steel was considerably softer at  $R_B$  10.

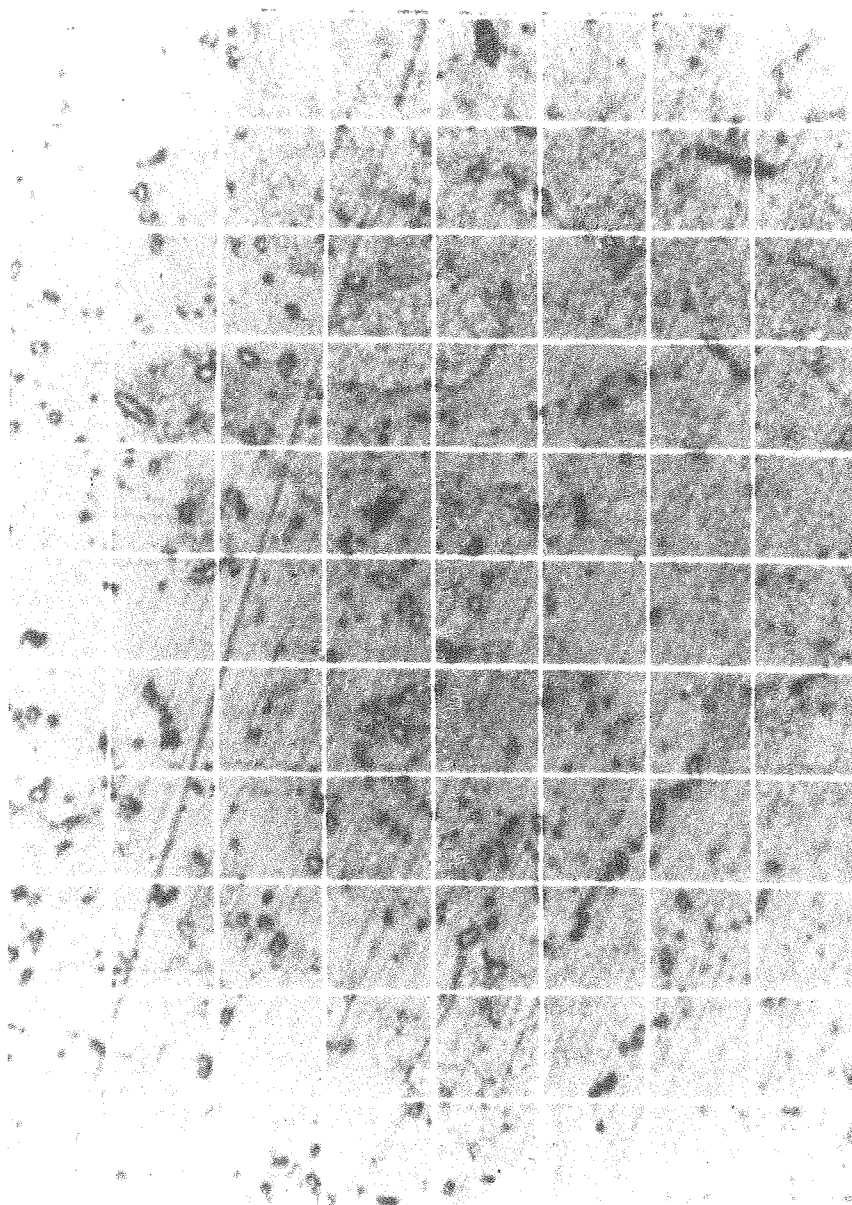
Figure 19

Figure 19. Spheroidized 1020 steel with intermediate carbide particle size, greater particle spacing and fewer particles.

AVERAGE PARTICLE SPACING	5.67	MICRONS
AVERAGE PARTICLE SIZE	1	MICRON
MINIMUM PARTICLE SIZE	.5	MICRONS
MAXIMUM PARTICLE SIZE	4	MICRONS

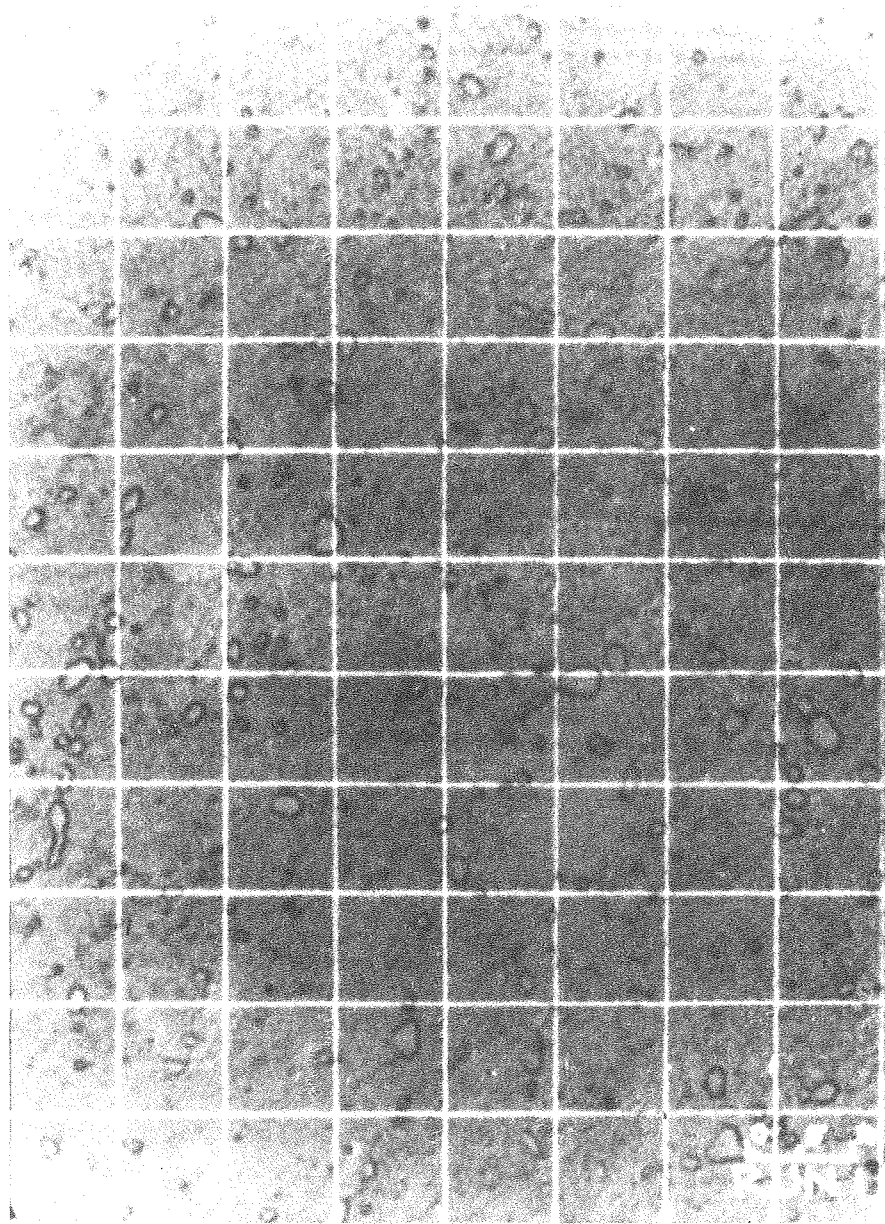
Figure 20

Figure 20. Spheroidized 1020 steel with very large sized particles, great particle spacing and relatively few particles.

AVERAGE PARTICLE SPACING	10 MICRONS
AVERAGE PARTICLE SIZE	3 MICRONS
MINIMUM PARTICLE SIZE	1 MICRON
MAXIMUM PARTICLE SIZE	5 MICRONS

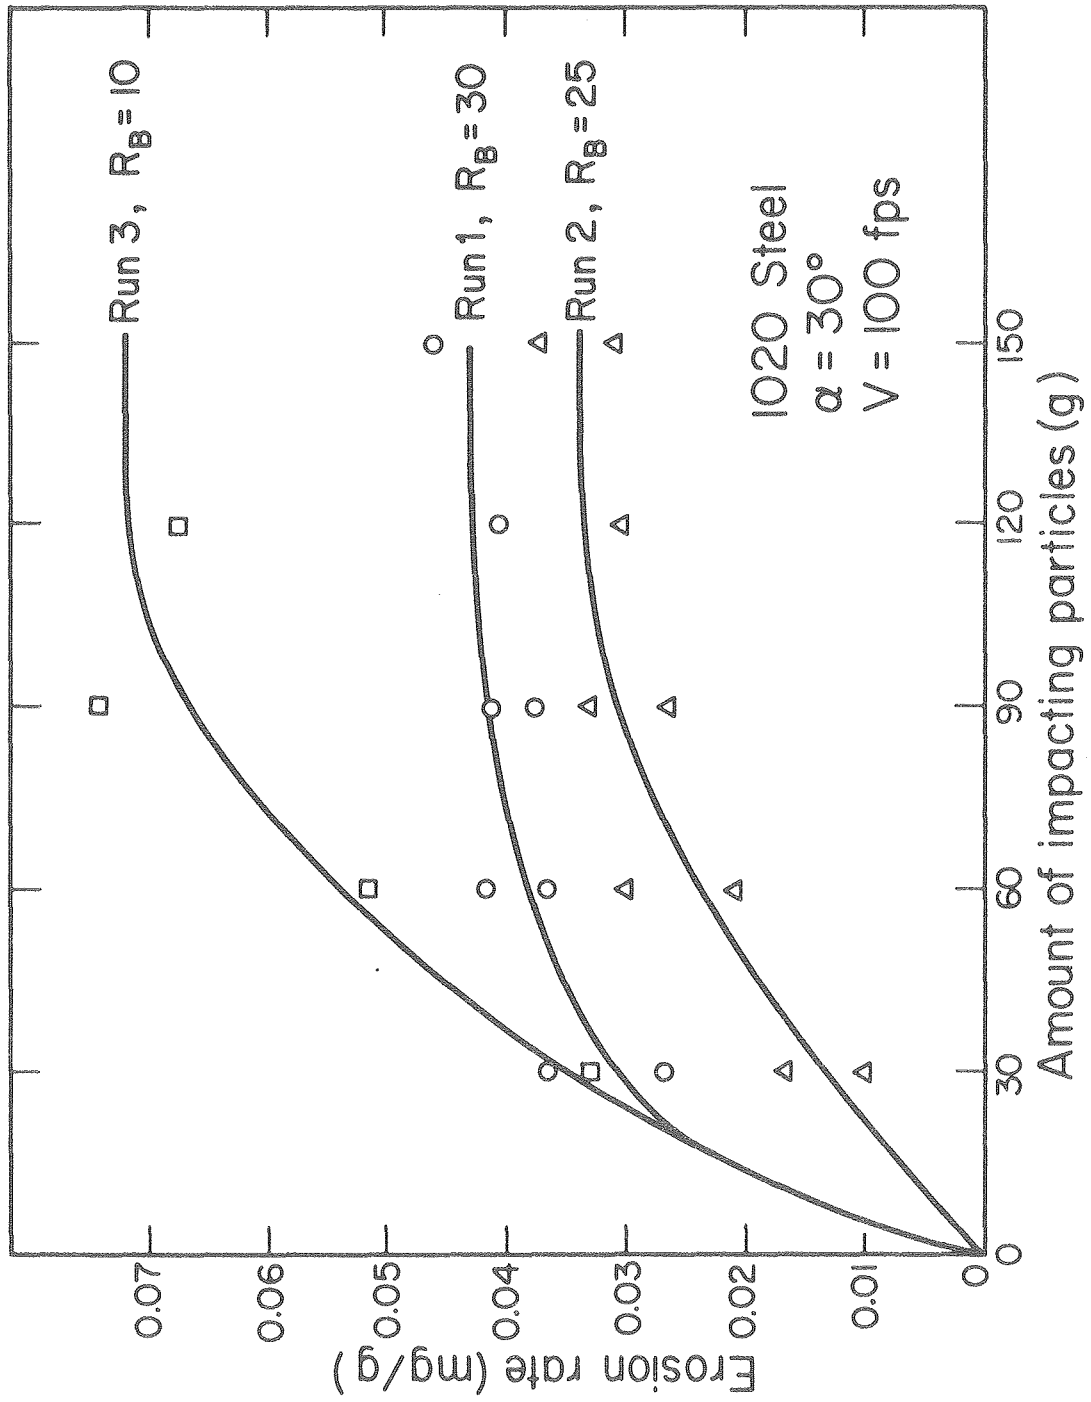
Figure 21 is a curve showing the erosion behavior of the three microstructures. It can be seen that the amount of erosion in Run 2 is 33 percent less than that in Run 1 at the steady state condition. Run 2 has an interparticle spacing twice that of Run 1, providing more soft, ductile ferrite structure between the hard carbide particles to plastically deform upon impact by the eroding SiC particles. The steel in Run 2 has a somewhat lower hardness than that used in Run 1. Run 3, on the other hand, is much softer than the other two runs' steel specimens with a much lower strength to resist erosion. It experienced roughly twice the erosion of the other two spheroidized specimens.

The three different microstructures used defined the range in which erosion is affected by the distribution and hard particles in a soft, ductile matrix. In Run 1, where the carbide particles were the smallest in size and greatest in quantity and distance between the hard particles, where the soft, ductile ferrite matrix occurred was the smallest, the erosion was greater than in Run 2. In Run 2 the 1/3 less erosion occurred because the brittle spheroids were consolidated into fewer, larger particles with more ductile ferrite between them. This permitted more plastic deformation of the surface to occur without material removal and the erosion was reduced.
